7 Jemison

Address: 6201 Auburn
 Parcel: 22093044
 District: 7
 SNF Area: Warrendale/Cody/Rouge
 Owner: City of Detroit
 Site Area: 3.21 ac
 Gross Floor Area: 34,900 sf
 Floors: 2
 Plan Type: T
 School Type: Elementary
 Year Built: 1924, 1925, 1951
 Zoned: R1
 Base Rehab Cost (est): \$1.5M
 Total Rehab Cost (est): \$9.5M

Building Overview

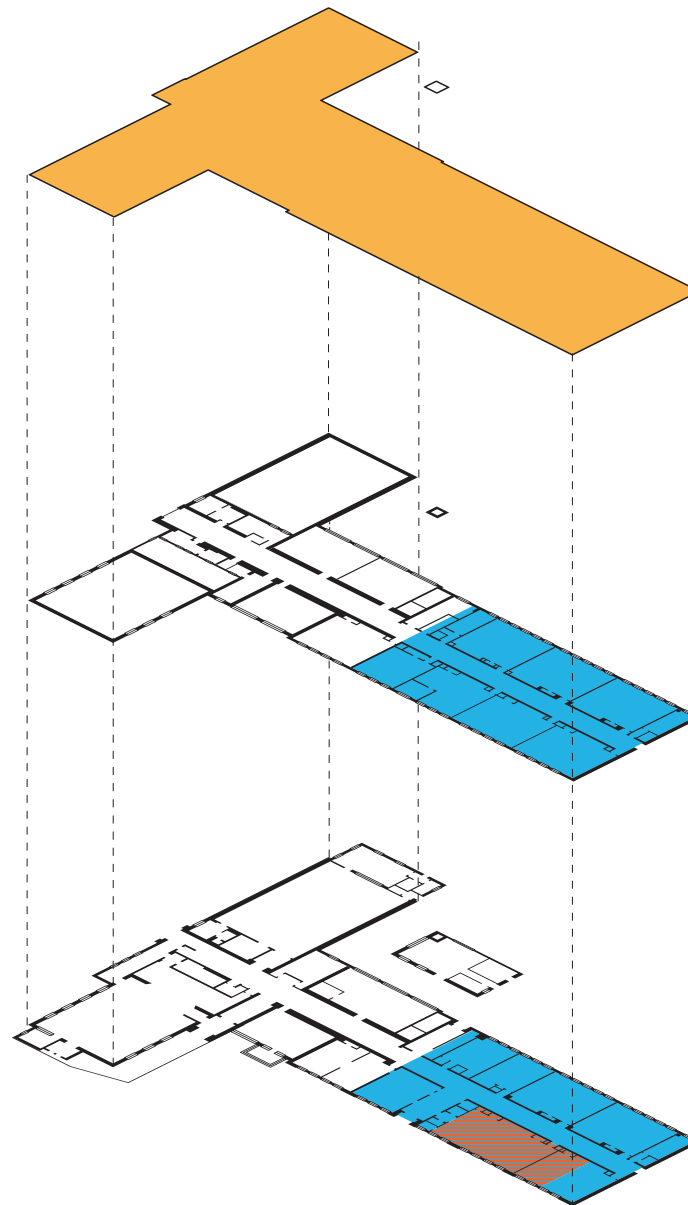
Building Distress

- Roof membrane is severely deteriorated; replace all.
- If mothballing building, install temporary roof immediately to protect structure.
- Replace roof drains and pipes.

- Heavy water infiltration in 1920s section; ceiling collapsed and finishes destroyed.
- 1950s finishes largely intact.
- Windows intact throughout.
- Radiators scrapped.
- Structure is sound throughout.

- Heavy water infiltration in 1920s section; finishes destroyed.
- Fire damage in kindergarten area; affects finishes only.
- 1950s finishes largely intact.
- Windows intact throughout.
- Radiators scrapped.
- Structure sound throughout.

- Roof Damage
- Structural Damage
- Water Damage
- Fire Damage
- Scrapping Damage

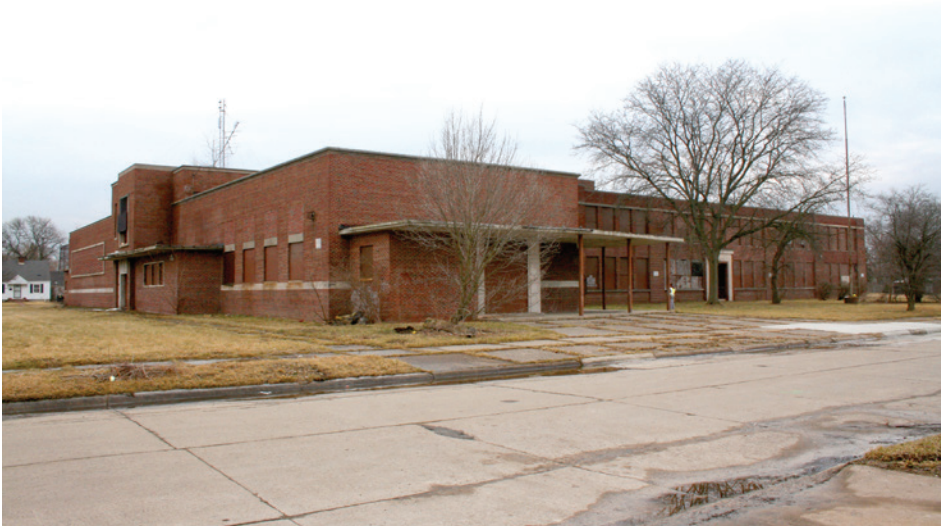
Exterior viewed from the northwest corner. The 1951 auditorium is visible in the foreground, with the gym located behind (far left of frame). The original 1920s classroom wing is visible on the right.

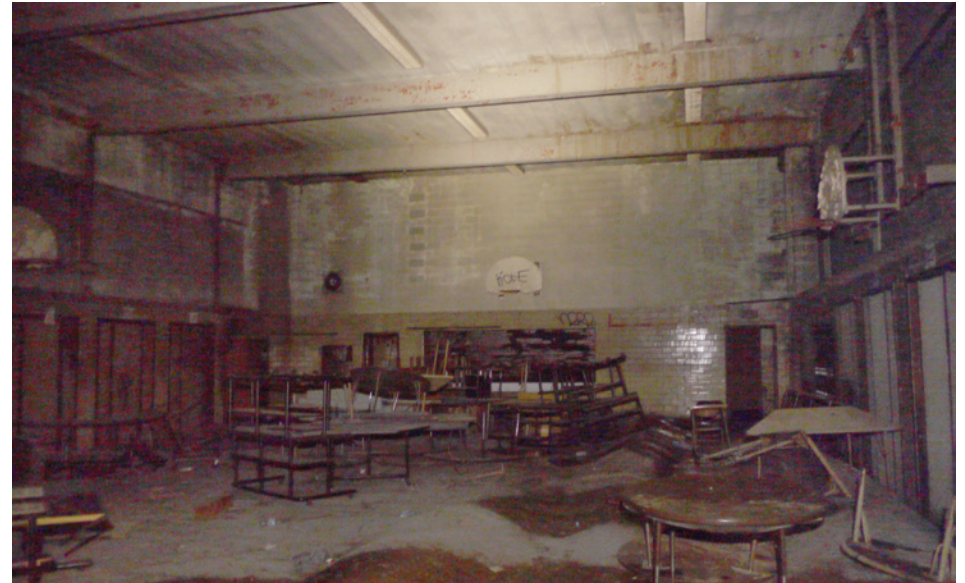
The 1951 gym is a windowless CMU box. Historic floorplans show that there were originally windows on both the north and south walls (presumably glass block matching the classroom addition). These windows were filled in with brick and CMU at an unknown time.

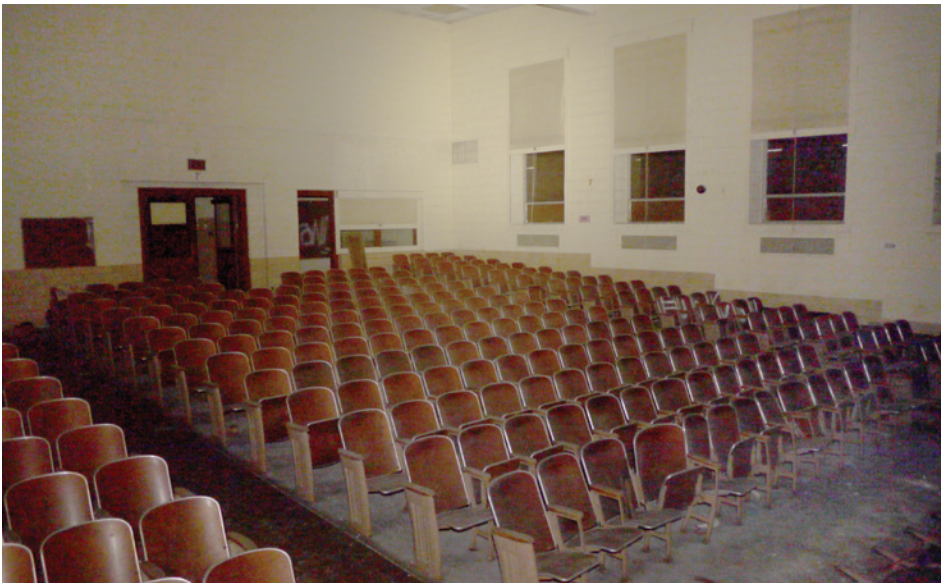
The auditorium is utilitarian CMU construction with no frills. While it is not a particularly beautiful or impressive space, it is solidly built and in relatively good condition. There is a dedicated entrance with vestibule and covered sidewalk near the street.

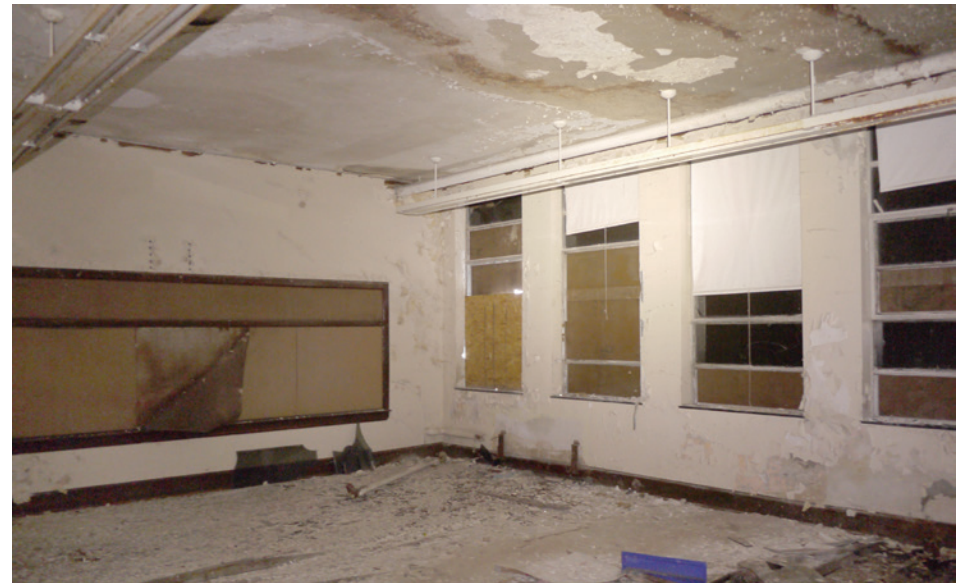
Operable steel windows are generally intact throughout the 1920s classroom wing. These likely date to the 1951 update of the building. Water damage is causing the plaster ceiling to sag.

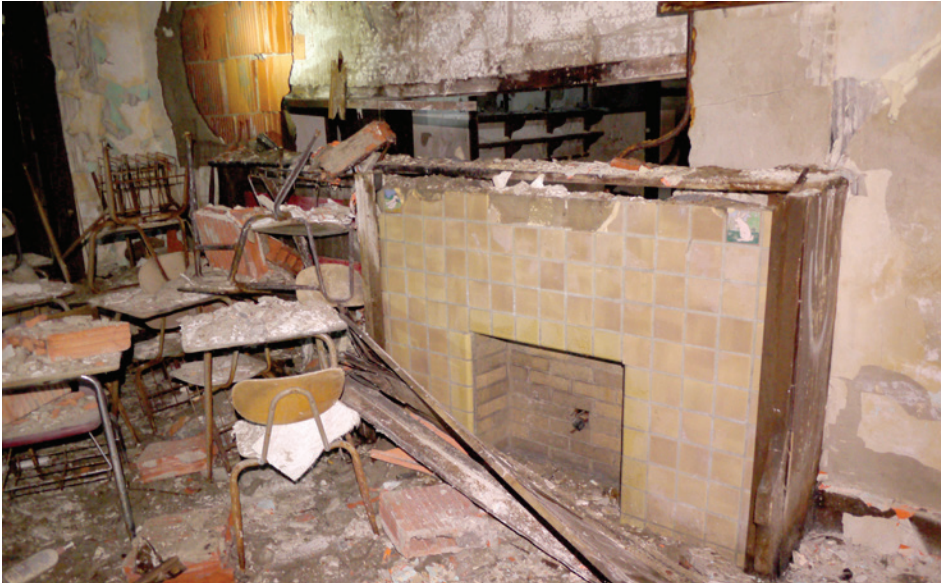
The kindergarten has been heavily damaged by water, fire, and scrapping. Most finishes have been destroyed, but this tile fireplace with prized Pewabic tiles may still be salvaged. Despite the rough appearance, however, the building's structure itself appears to be sound.

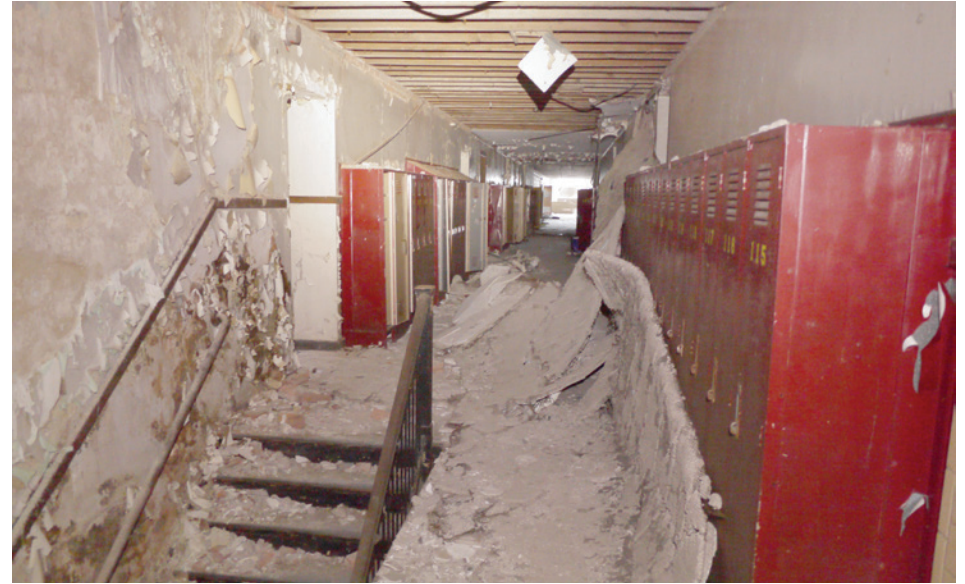
Corridors in the original south unit are 10' wide wall to wall, but feel narrower due to locker banks added later. Water infiltration in the south unit has caused the second floor's plaster ceiling to collapse and has caused widespread water damage in classrooms on both floors.

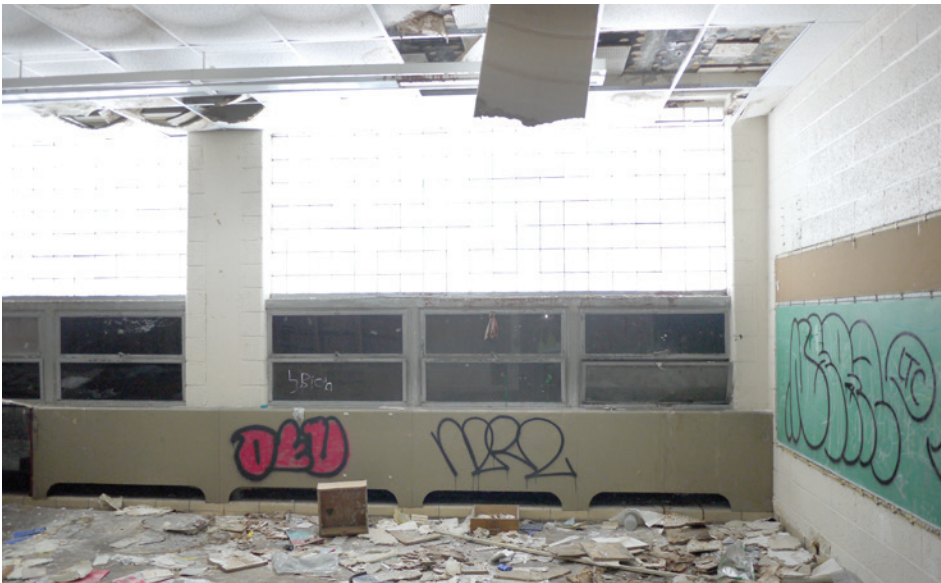
A typical classroom in the 1951 wing, featuring large glass block windows with operable steel frame lites below. The more durable painted CMU finishes in the newer wing are in relatively good shape compared to the moisture-sensitive plaster of the 1920s wing.

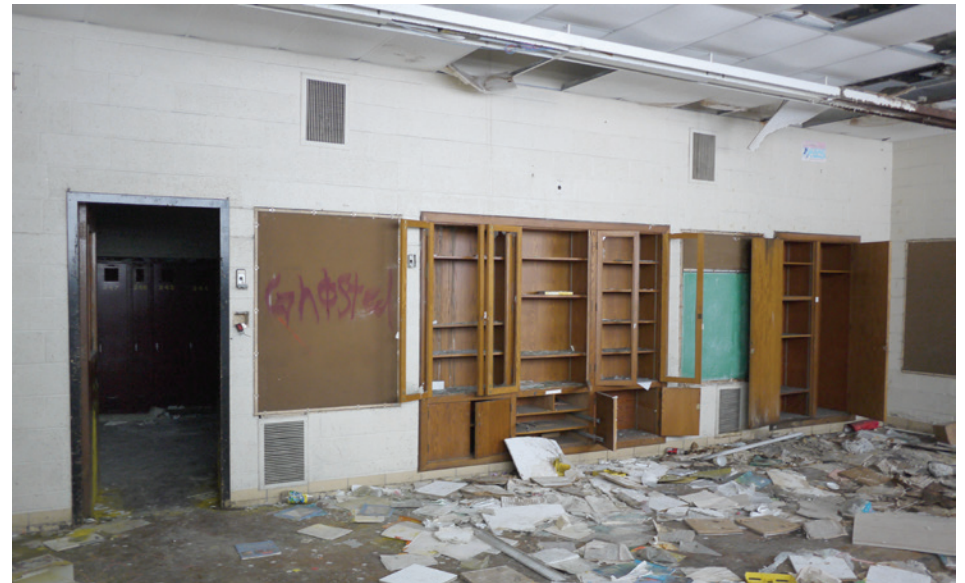
Built-in casework and other finishes in the 1951 classrooms are in good overall condition.
