7 Jemison

Address: 6201 Auburn
 Parcel: 22093044
 District: 7
 SNF Area: Warrendale/Cody/Rouge
 Owner: City of Detroit
 Site Area: 3.21 ac
 Gross Floor Area: 34,900 sf
 Floors: 2
 Plan Type: T
 School Type: Elementary
 Year Built: 1924, 1925, 1951
 Zoned: R1
 Base Rehab Cost (est): \$1.5M
 Total Rehab Cost (est): \$9.5M

Building Overview

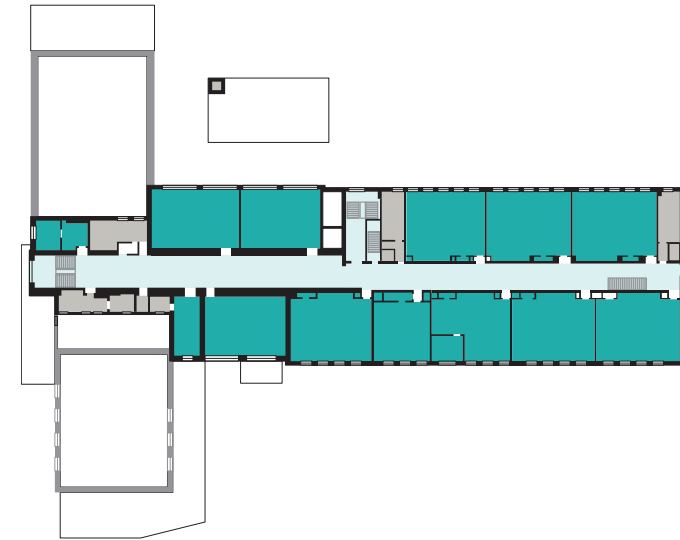
Second Floor

- Heavy water infiltration in 1920s section; ceiling collapsed and finishes destroyed.
- 1950s finishes largely intact.
- Windows intact throughout.
- Radiators scrapped.
- Structure is sound throughout.

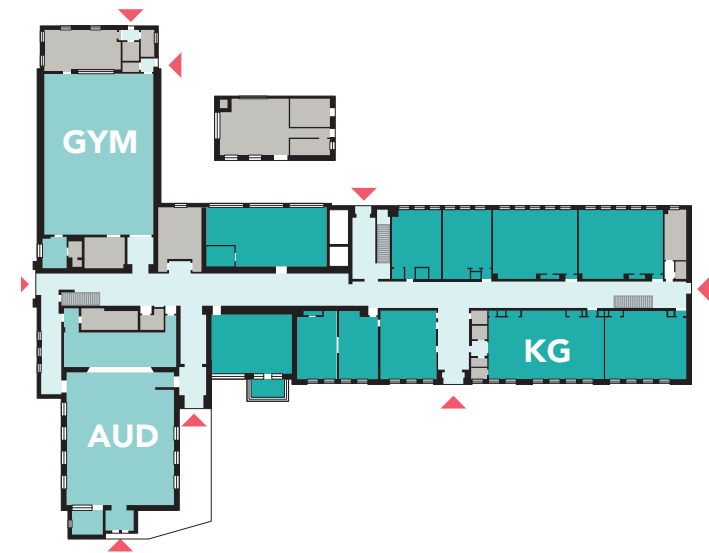
First Floor

- Heavy water infiltration in 1920s section; finishes destroyed.
- Fire damage in kindergarten area; affects finishes only.
- 1950s finishes largely intact.
- Windows intact throughout.
- Radiators scrapped.
- Structure sound throughout.
