VACANT HISTORIC SCHOOL BUILDINGS DISPOSITION PLAN

Building Envelope and Structural Assessment Report

Crockett High School

Basic Property Information: COD 3-Crockett-8950 St Cyril

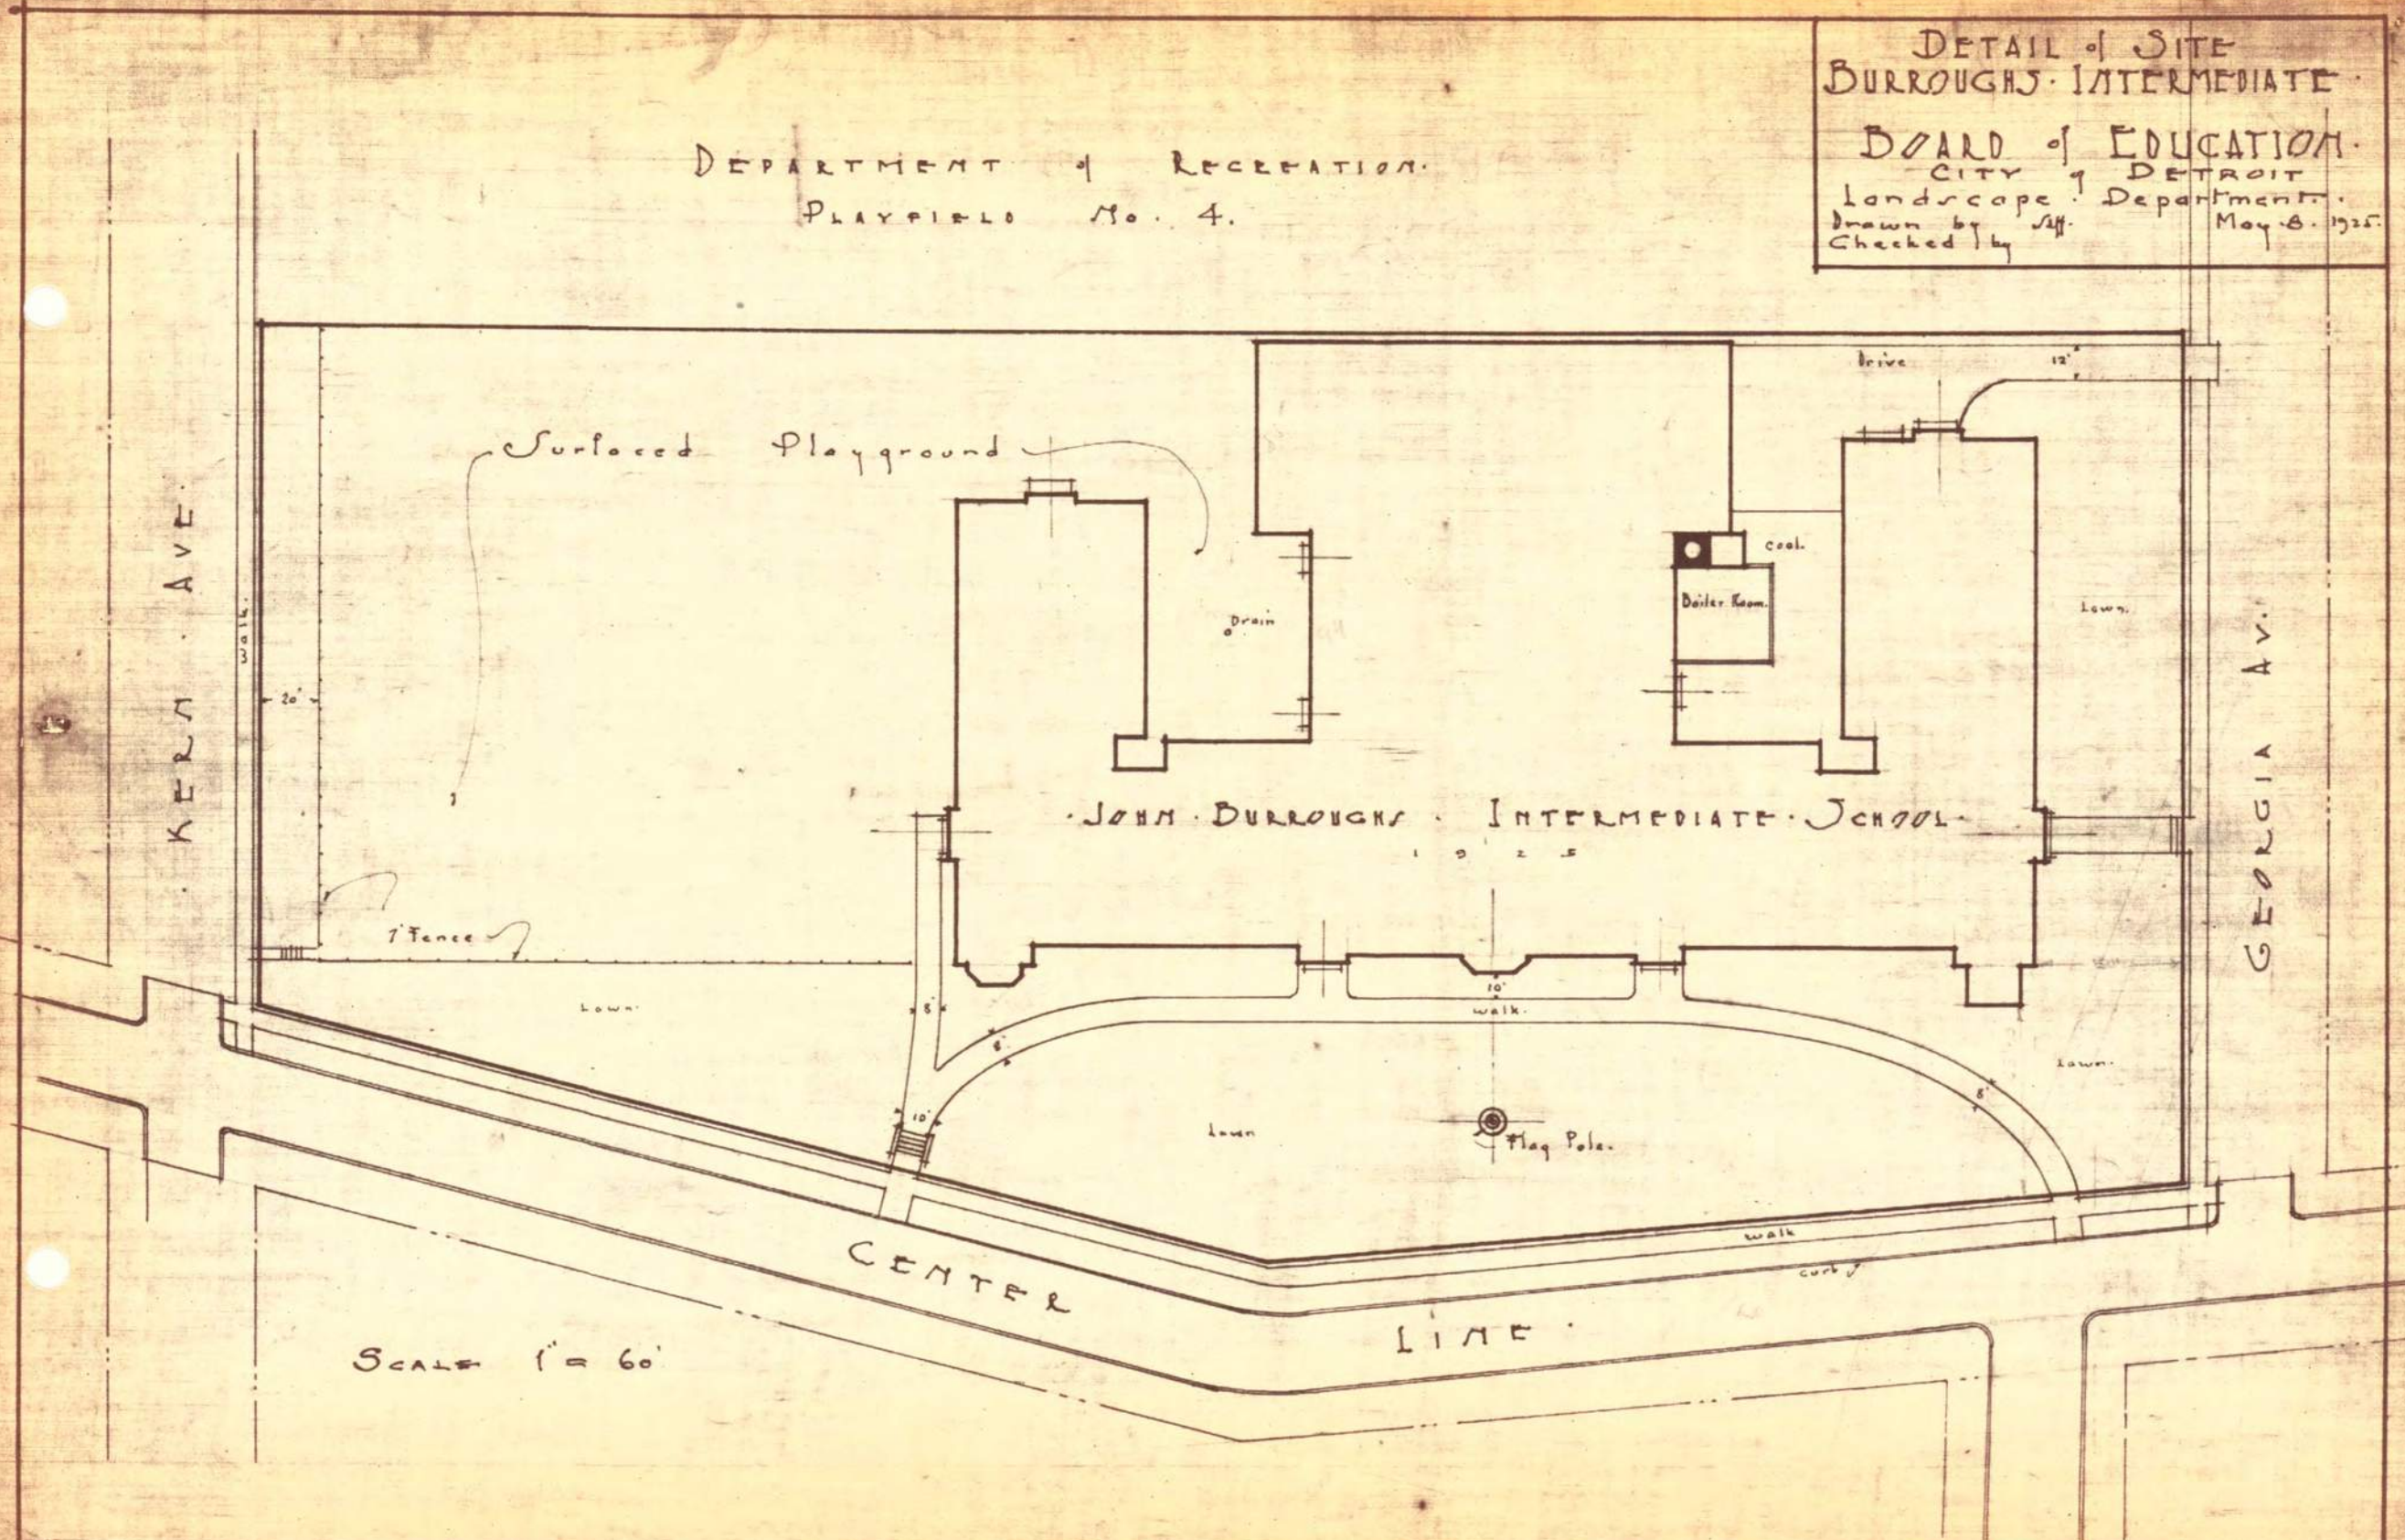
DEPARTMENT of RECREATION
PLAYFIELD No. 4.

DETAIL of SITE
BURROUGHS INTERMEDIATE
BOARD of EDUCATION
CITY of DETROIT
Landscape Department
Drawn by S.H.
Checked by
May 8, 1925.

SCALE 1" = 60'
